Township of Piscataway

Energy Savings Plan

December 7, 2023

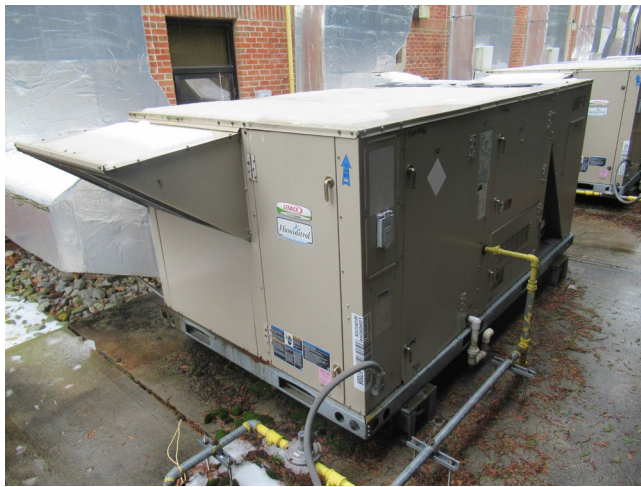
Existing packaged units (RTUs) at JFK Library.

Building	Existing Packaged Units	New Units
Senior Center	(1) Lennox LGH036, 3-ton, Packaged Unit	(1) Lennox LGT036, 3-ton, Packaged Unit
	(2) Lennox LGH092, 7.5-ton, Packaged Unit	(2) Lennox LGT092, 7.5-ton, Packaged Unit
	(4) Lennox LGH102, 8.5-ton, Packaged Unit	(4) Lennox LGT102, 8.5-ton, Packaged Unit
	(1) Lennox LGH120, 10-ton, Packaged Unit	(1) Lennox LGT120, 10-ton, Packaged Unit
Westergard Library	(1) Aeon RM-025, 25-ton, HW Heat Packaged Unit	(1) Aeon RN-025, 25-ton, HW Heat Packaged Unit
	(1) Aeon CA-08-2, 7.5-ton, Electric Resistance Heat Split System	(1) Trane TWA072/TWE072 Heat Pump + HW Heat Split System

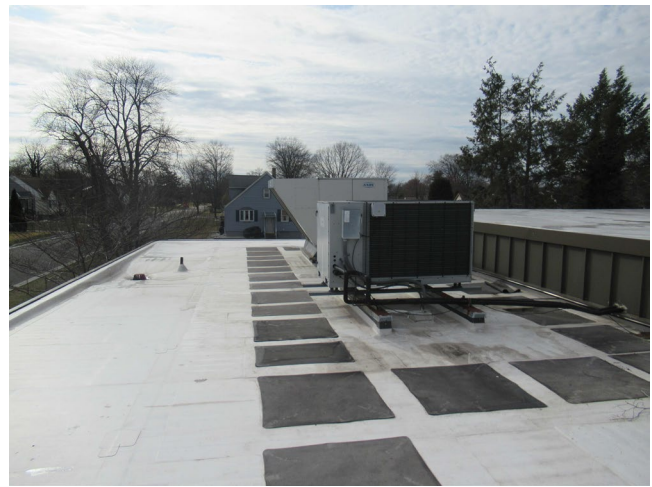
Existing packaged and split system units at Westergard Library

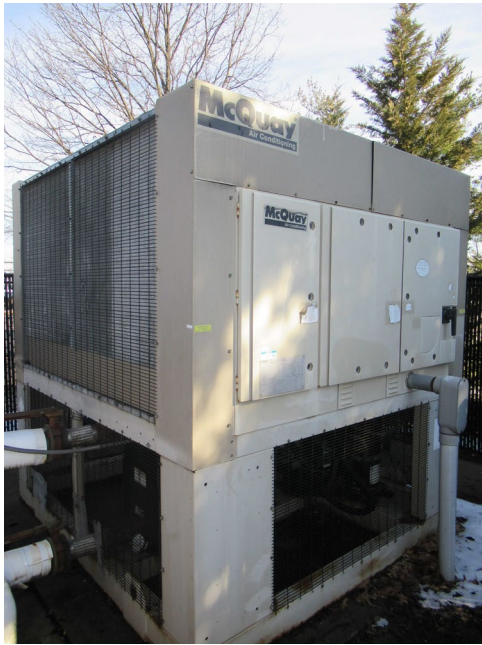
Existing air-cooled chiller at the Town Hall.

The Town Hall has one air-cooled chiller serving the building cooling load. The air-cooled chiller is 19 years old and nearing the end of its useful life. Existing pumps will be replaced along with the air-cooled chiller.

Building	Existing Air-Cooled Chillers	New Air-Cooled Chillers
Town Hall	(1) McQuay AGZ055, 55-ton Air-Cooled Chiller	(1) Daikin AGZ004F, 54-ton Air-Cooled Chiller
JFK Library	(1) Trane RTAA100A, 100-ton Air-Cooled Chiller	(1) Daikin AGZ006F, 100-ton Air-Cooled Chiller

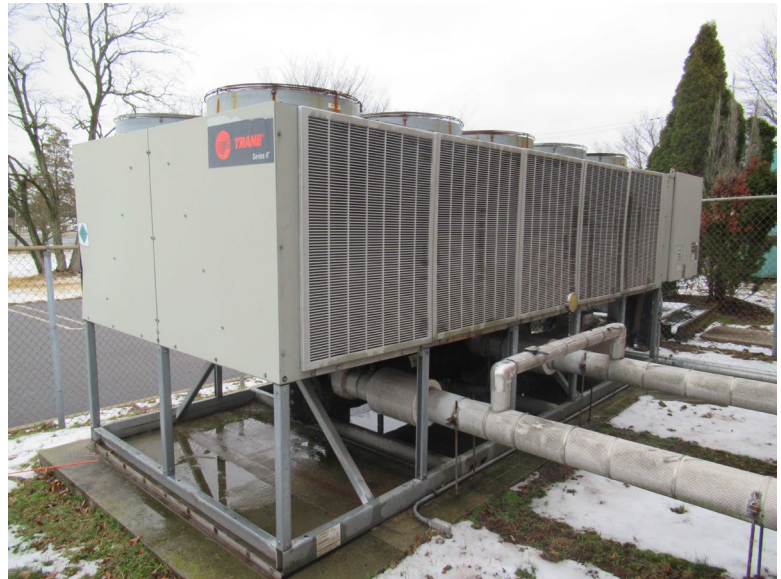
Existing air-cooled chiller at JFK Library.

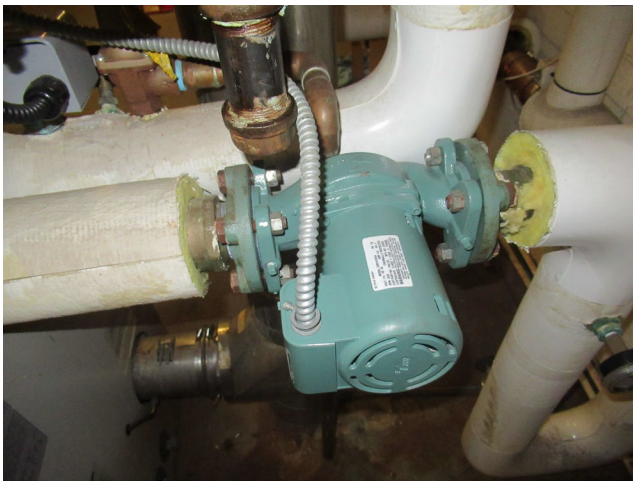
Existing boiler circulation pump at DPW (typical of 2).

Existing circulator pumps serving two boilers do not have a suction diffuser or the proper straight length of pipe on the inlet side of the pump. It is recommended that pumps have 5-10 times the pipe diameter of straight pipe on the inlet of the pump or an optional suction diffuser for proper pump operation. Without the required length of straight pipe or a suction diffuser the pump's expected service life is reduced. Piscataway replaces the boiler circulation pumps every year at DPW, so this measure will result in operational and maintenance savings by replacing each 90° elbow into the circulator pumps with a suction diffuser.

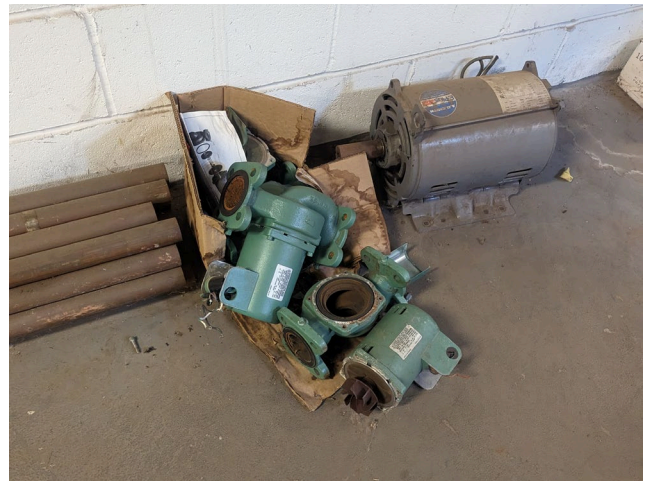
Pile of recently replaced boiler circulation pumps.

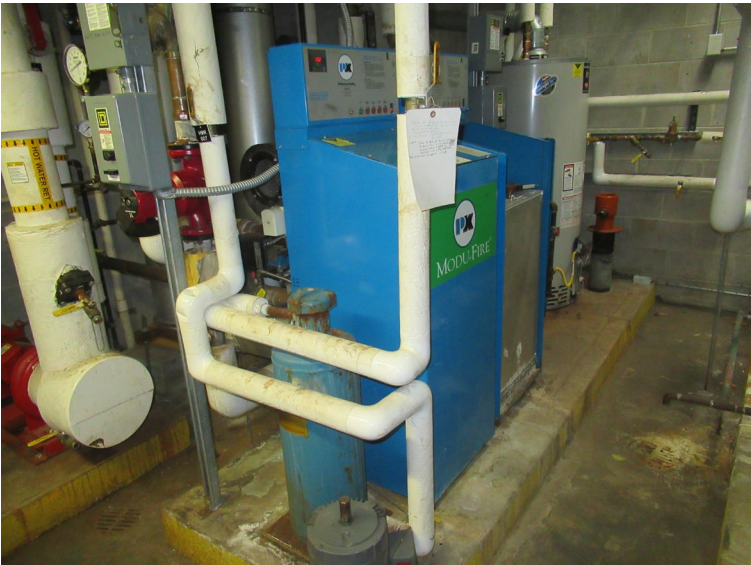
Existing non-condensing boilers at JFK Library.

(2) IBC model EX-850,
825 MBH output, 97% eff.
